Playground Safety Inspection

Inspection Date: 19 February 2022

Site Name: Princeton Park Trails II
Address: 1615 Blackburn Way

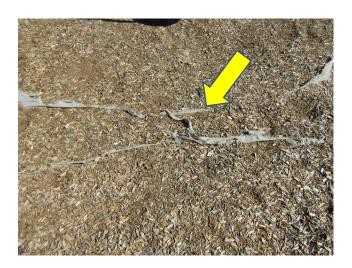
Large strips of geotextile fabric is exposed in several locations creating trip hazards.

Geotextile fabric exposed

>Fabric needs to be repositioned under the EWF (Engineered Wood Fiber).

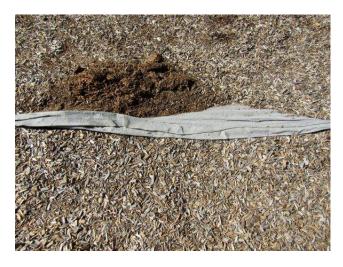
Fabric exposed

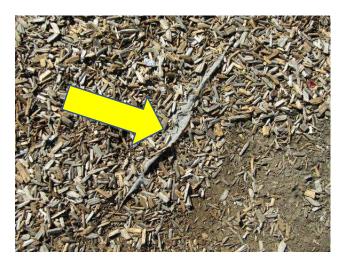
Fabric exposed

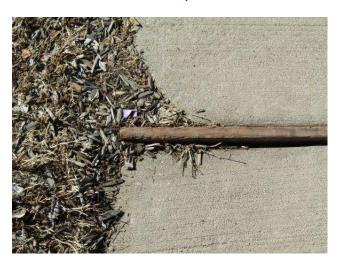
Sidewalk wood spacer is pulled away from the ground creating a trip hazard next to middle Shade Bench.

Sidewalk spacer creating trip hazard

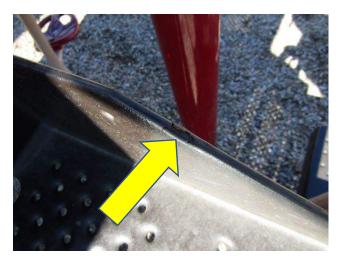
Very MINOR PVC damage on transfer station steps. Continue to monitor. Tightened 90% of all hardware throughout entire play structure during inspection.

MINOR PVC damage transfer station steps

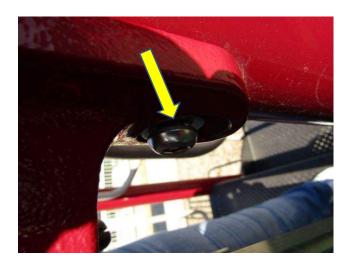
Tightened all loose hardware

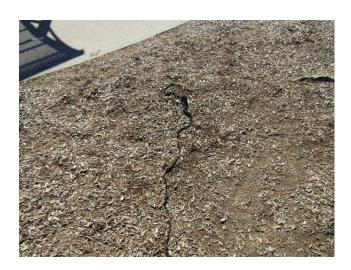
Geotextile fabric exposed in several locations in play area.

Fabric Exposed

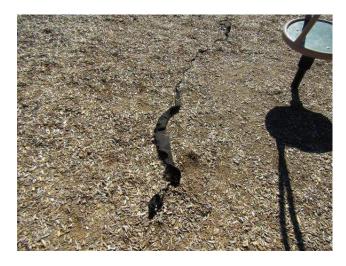
Fabric Exposed

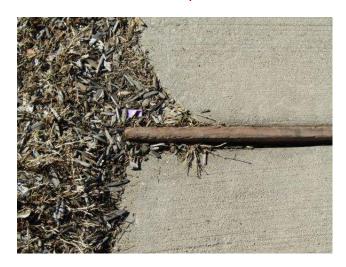
Wood sidewalk spacer is pulled up creating a trip hazard near center shade bench.

Sidewalk Spacer coming up

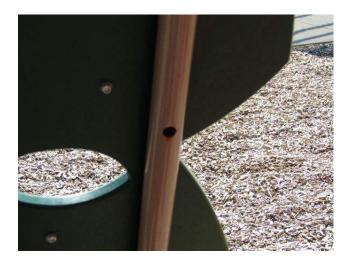
Missing bolt on Wall Climber (Replaced during inspection)

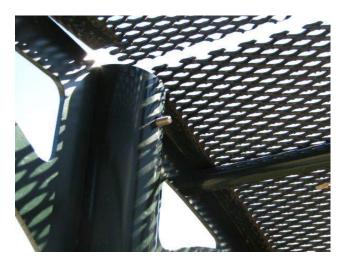
Missing nut for bolt

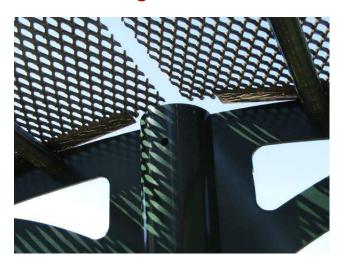
Shade Bench Missing Bolt

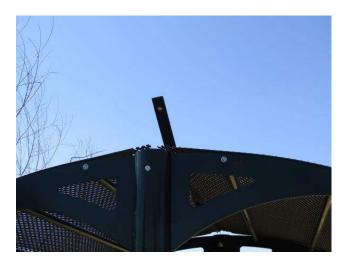
Shade Bench Bracket needs to be secured

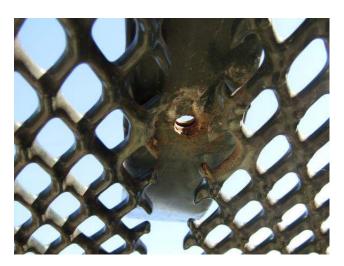
Shade Bench Missing Bolt

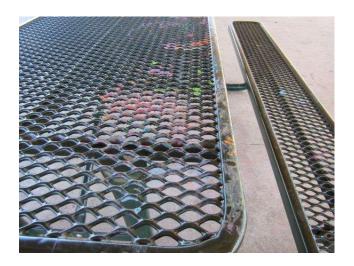
Paint on Table
